**THE I-270 / US 15
MULTI - MODAL CORRIDOR STUDY**
Project No. FR192B11

**PRELIMINARY SCREENING ASSESSMENT OF
TRANSPORTATION CORRIDOR ALIGNMENTS**

**PRELIMINARY SCREENING ASSESSMENT REPORT
MARCH 1999**

RUMMEL, KLEPPER & KAHL, LLP

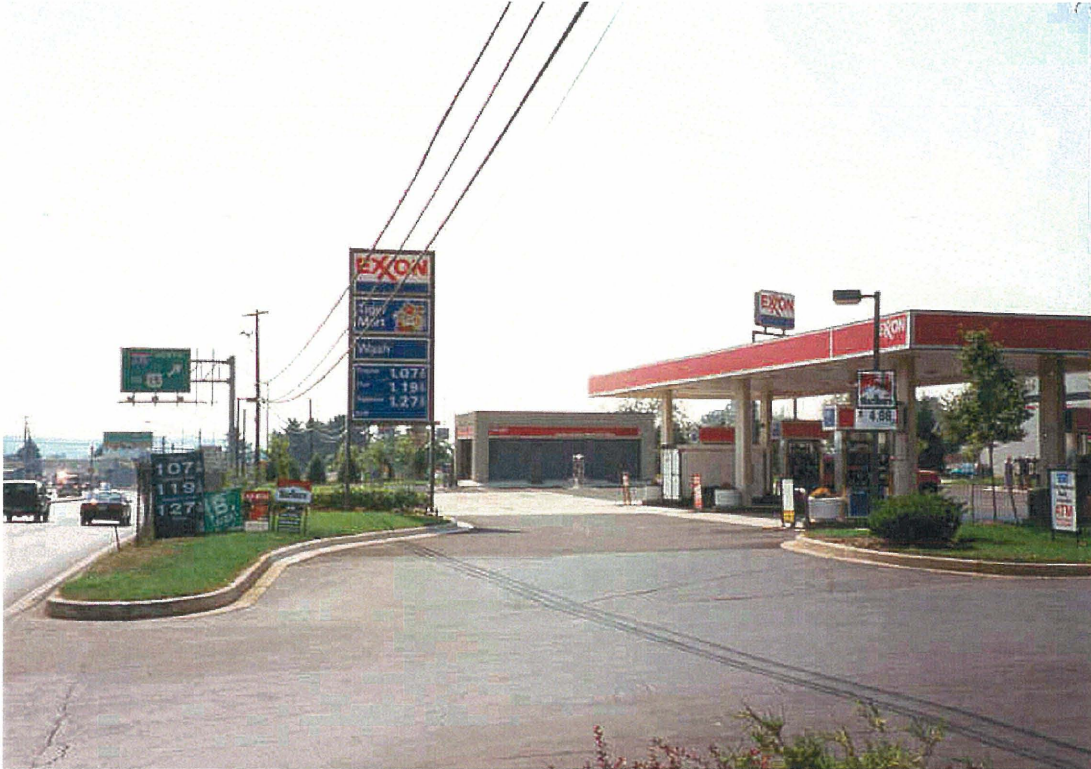
Photo 3 – Exxon: Buckeystown Pike at I-270

1. **Exxon RAS #2-6583**, 5516 Buckeystown Pike, Frederick, Maryland, MDE Case No. 90-2413FR: at this site adjoining the ramp from southbound Buckeystown Pike to northbound I-270, a gasoline release was detected in 1990 (Photograph 3). Dissolved hydrocarbon concentrations were monitored and reported semiannually. During station renovation in June and July 1997, the USTs were replaced and 1,284 tons of contaminated soil were removed for offsite remediation. The following documents from the MDE file summarize the case and are included in Appendix D.

Although unanticipated contamination may remain at or near the leaking UST facilities, review of the available documentation indicates that these sites do not appear to present a significant risk to construction of the transportation alignment alternatives under consideration.

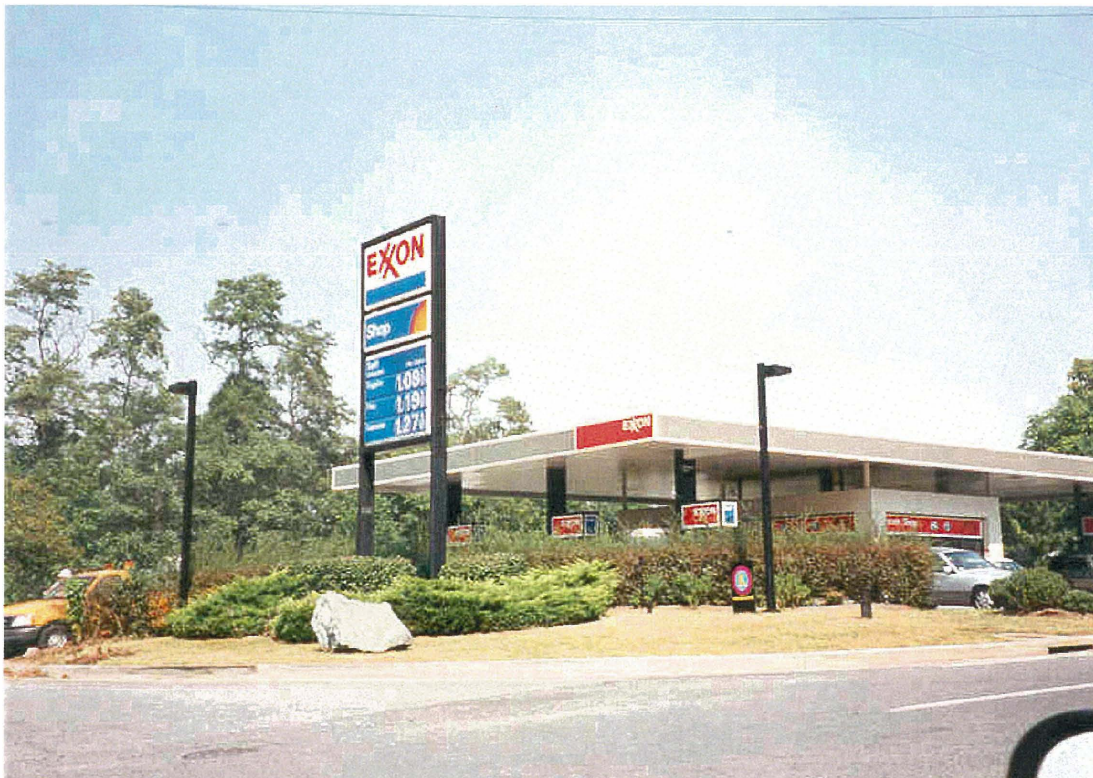
Photo 4 – Exxon Station, Fingerboard Road, Urbana

2. **Urbana Exxon**, 8816 Fingerboard Road, Urbana, Maryland (Photograph 4). The database search identified this site located near the northbound I-270 ramps, as a facility with a leaking UST case file. However, the MDE file contained no reference to UST leaks or releases

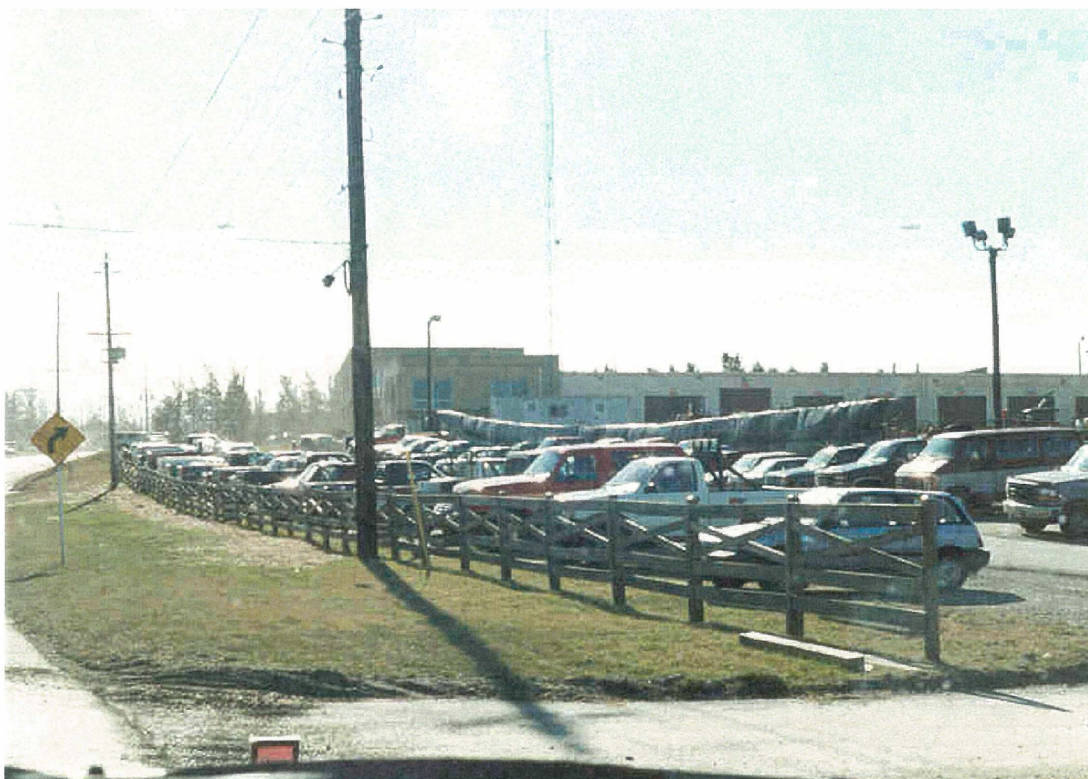
Photo 6 – Pleasant Excavating Co., Frederick Road

RK&K identified nine facilities within the study area based on their proximity to proposed alignments and observation of site operations including heavy equipment storage and maintenance, UST replacement, monitoring well installation, or electrical power distribution. Although these sites have not been identified in the regulatory databases as contaminant release sites, the sites should be considered as potential sources of environmental contamination during construction of transportation alignment alternatives.

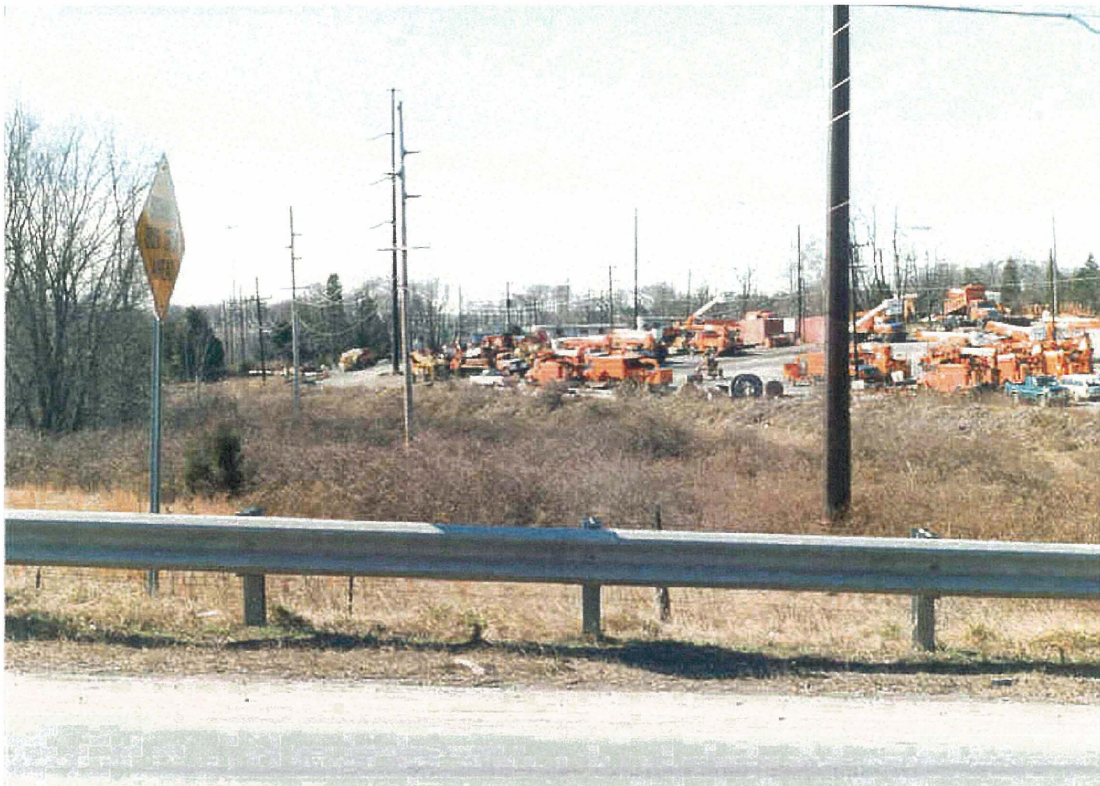
Photo 9 – Asplundt Tree Service, Frederick Road

6. **Asplundt Tree Service, Inc.**, 23630 Frederick Road, Clarksburg, Maryland: located between I-270 and Frederick Road (Photograph 9). Asplundt uses this site for staging and storing trucks and equipment. No permanent facilities were visible. On-site fueling of equipment was being performed from a contractor-owned tanker truck.

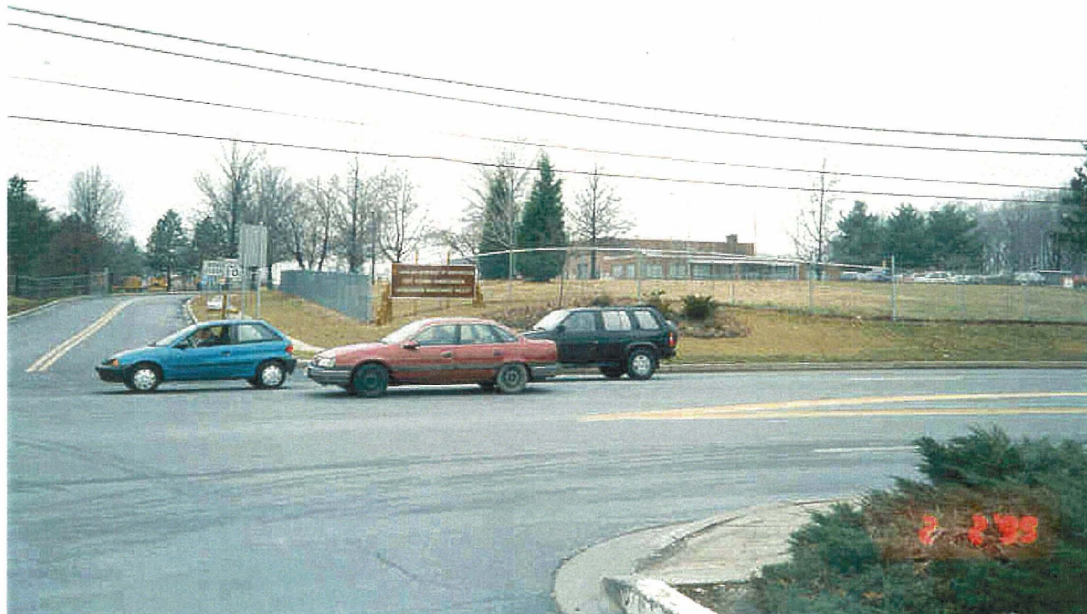
Photo 13 – SHA Maintenance Facility, Quince Orchard Road

3. Maryland State Highway Administration, 502 Quince Orchard Road, Gaithersburg, Maryland, 94-2941 M02: this site adjoins the CSX corridor (Photograph 13). During removal of two USTs in June 1994, gasoline-contaminated soil was encountered. Approximately 100 tons of impacted soil was removed for offsite remediation and disposal. MDE placed the case on the inactive docket in November 1994. Representative documents from the MDE case file are listed below and included in Appendix D.

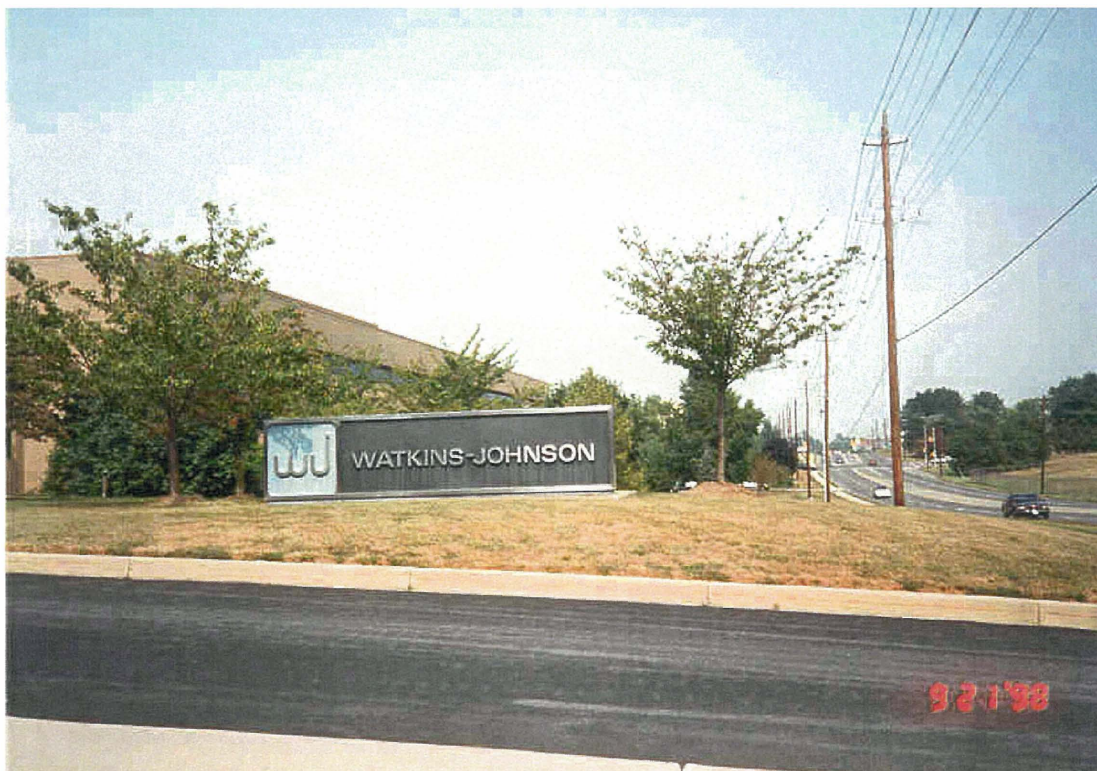
Photo 14 – Watkins Johnson Facility, Quince Orchard Road

2. **Watkins-Johnson Company**, 700 Quince Orchard Road, Gaithersburg, Maryland: this site adjoins the Transitway alignment (Photograph 14). A preliminary assessment was performed to investigate unspecified contamination. Based on the assessment results, EPA issued a NFRAP finding in 1991.

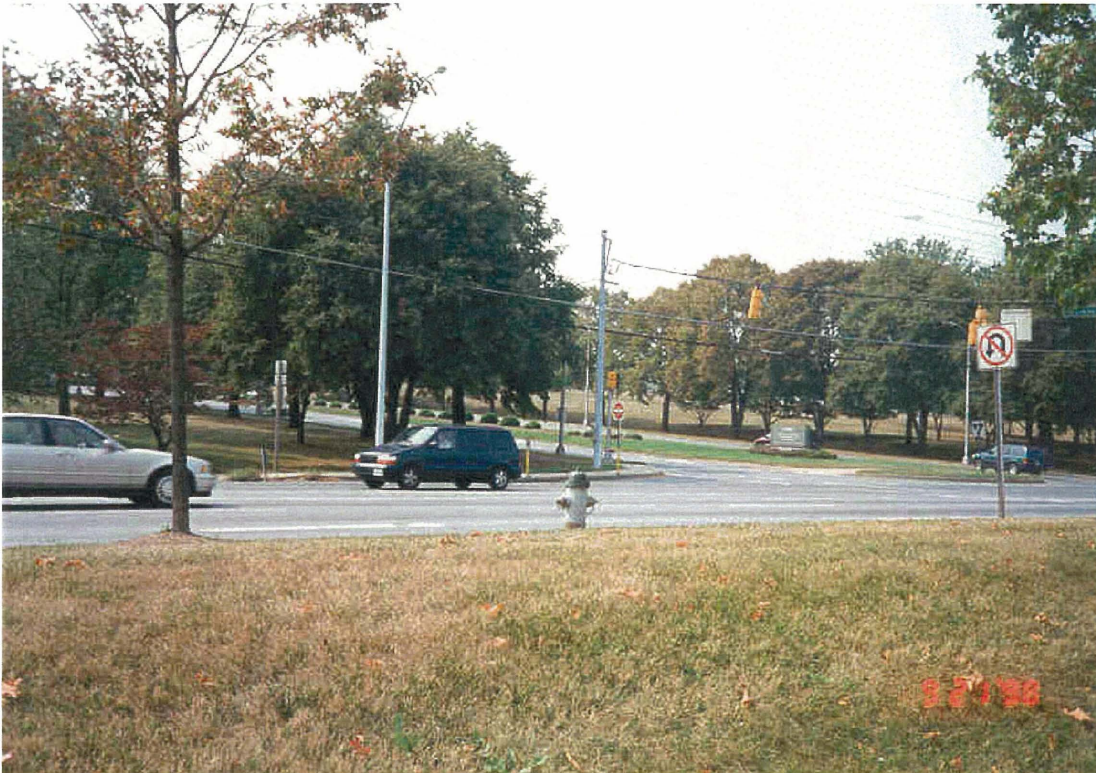
Photo 15 – NIST, Quince Orchard Road

3. **National Institutes of Standards and Technology (NIST)**, 100 Bureau Drive, Gaithersburg, Maryland: this facility adjoins the Transitway alignment (Photograph 15). EPA issued a NFRAP decision following a Preliminary Assessment of an unspecified contaminant discovery. The location of the spill within the NIST facility was not provided.

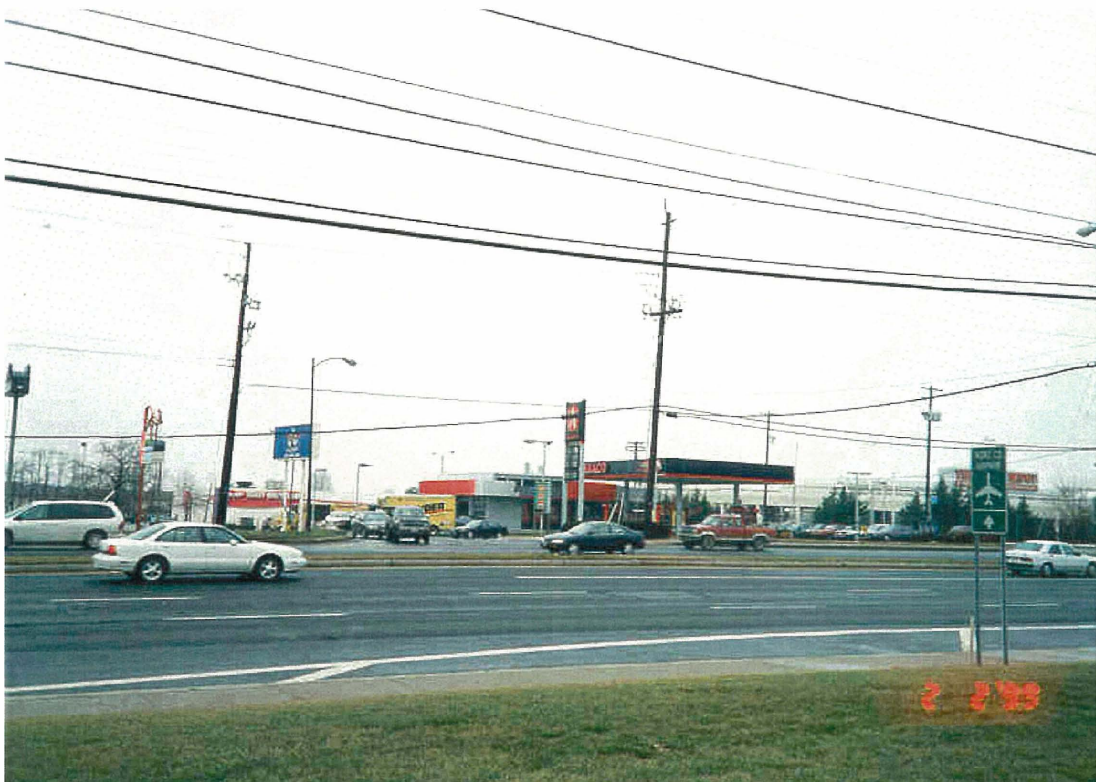
Photo 16 – Texaco, Shady Grove Road

5. Texaco Station No. 23-068-322, 15730 Shady Grove Road, Gaithersburg, Maryland, Case No. 9-1142 MO1: this site is located near the ramp to northbound I-270 (Photograph 16). A gasoline release was discovered in January 1989 prior to UST replacement in March 1989. Texaco operated a remediation system consisting of total fluids recovery, air stripping, carbon filtration, and soil vapor extraction through 1995. Groundwater monitoring was discontinued in November 1996 following MDE file closure. Appendix D contains the following documents from the MDE file:

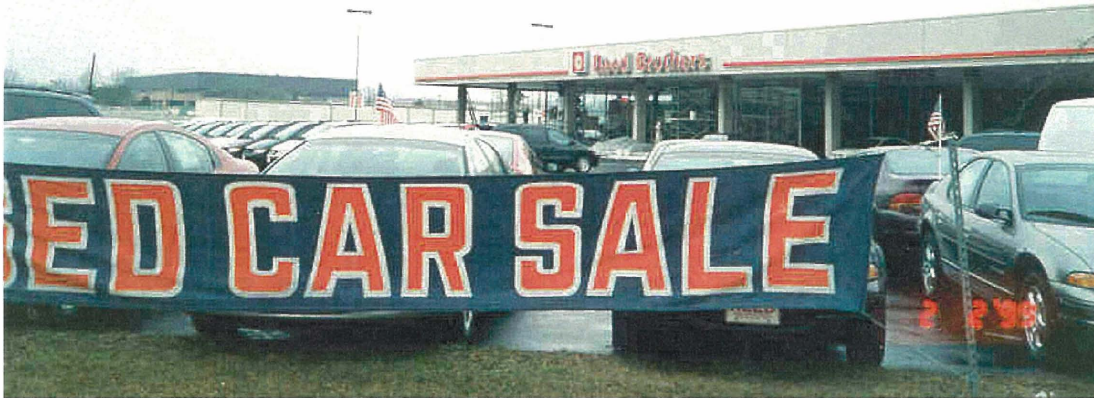
Photo 17 - Reed Bros. Dodge, Frederick Road

6. Reed Brothers Dodge, 15955 Frederick Road, Rockville, Maryland, MDE Case No. 92-1490 M02: the proposed Transitway alignment crosses this property (Photograph 17). Petroleum product was observed on the groundwater during removal of two USTs in 1992. Groundwater monitoring continued until June 1997 when MDE issued a notice of compliance (Appendix D).
